ARLINGTON STREET CHURCH BROWNSTONE RESTORATION MASTER PLAN OVERVIEW

ARLINGTON
STREET CHURCH
Unitarian Universalist

Bruner/Cott
ARCHITECTS

SIMPSON
GUMPERTZ
& HEGER

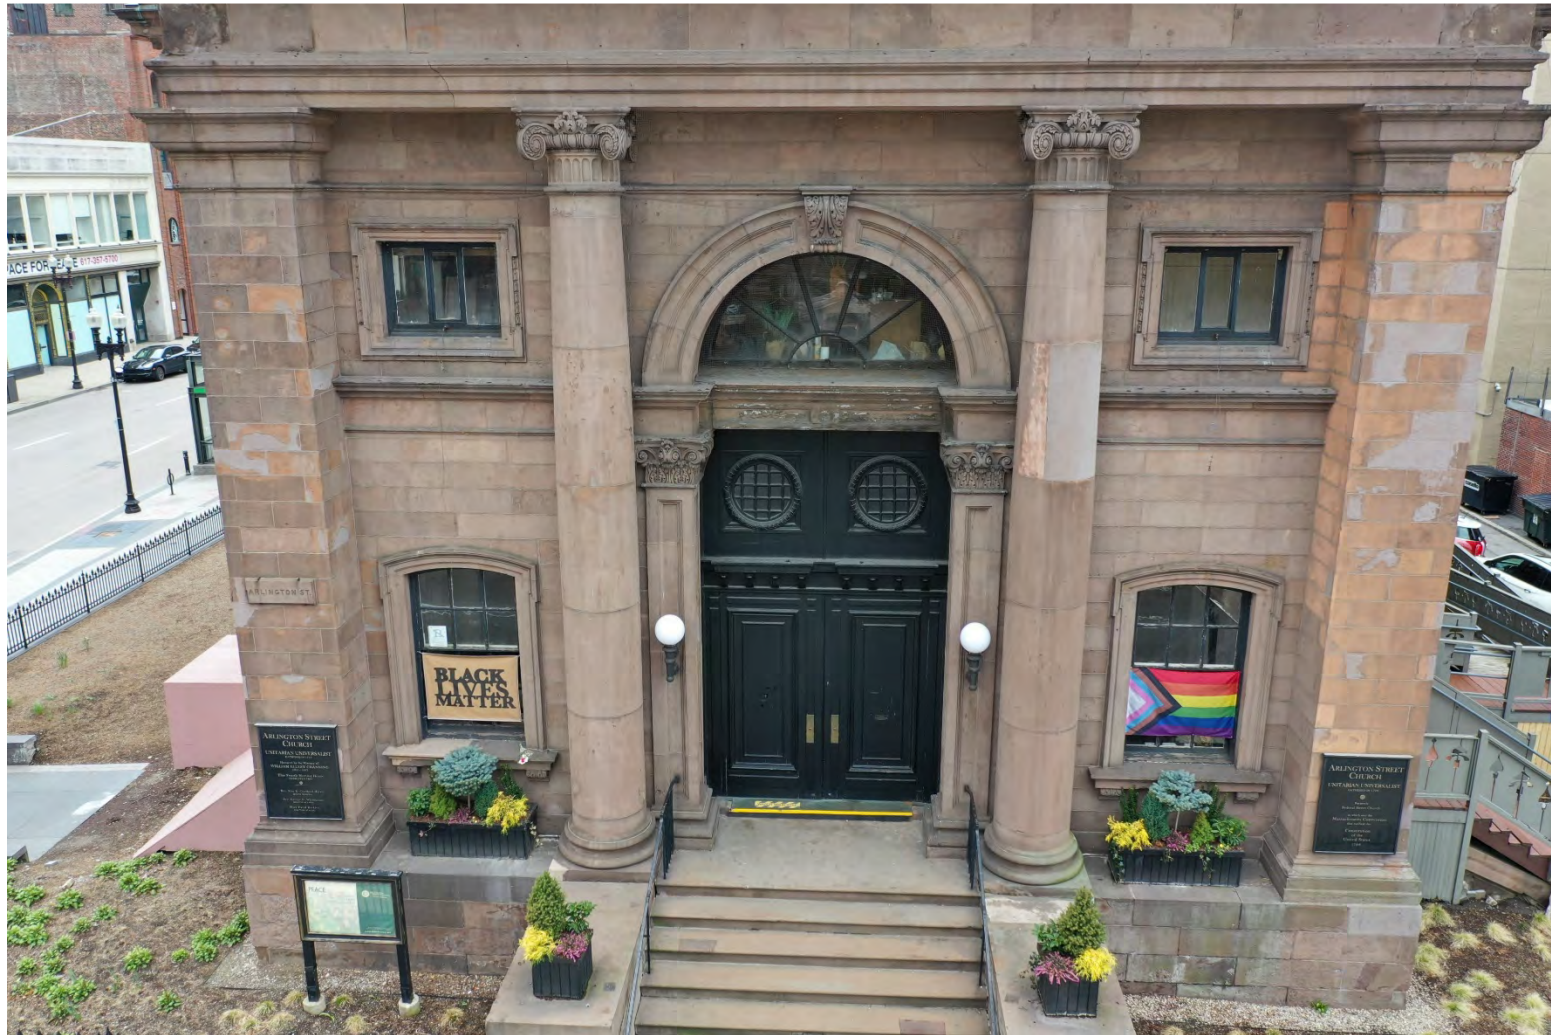
View of east façade with stain on north pilaster and failing composite repair mortar patches throughout facade. Composite repair mortar will be removed and repaired with harvested stone. Stains at north pilaster will be removed by resurfacing the stone.

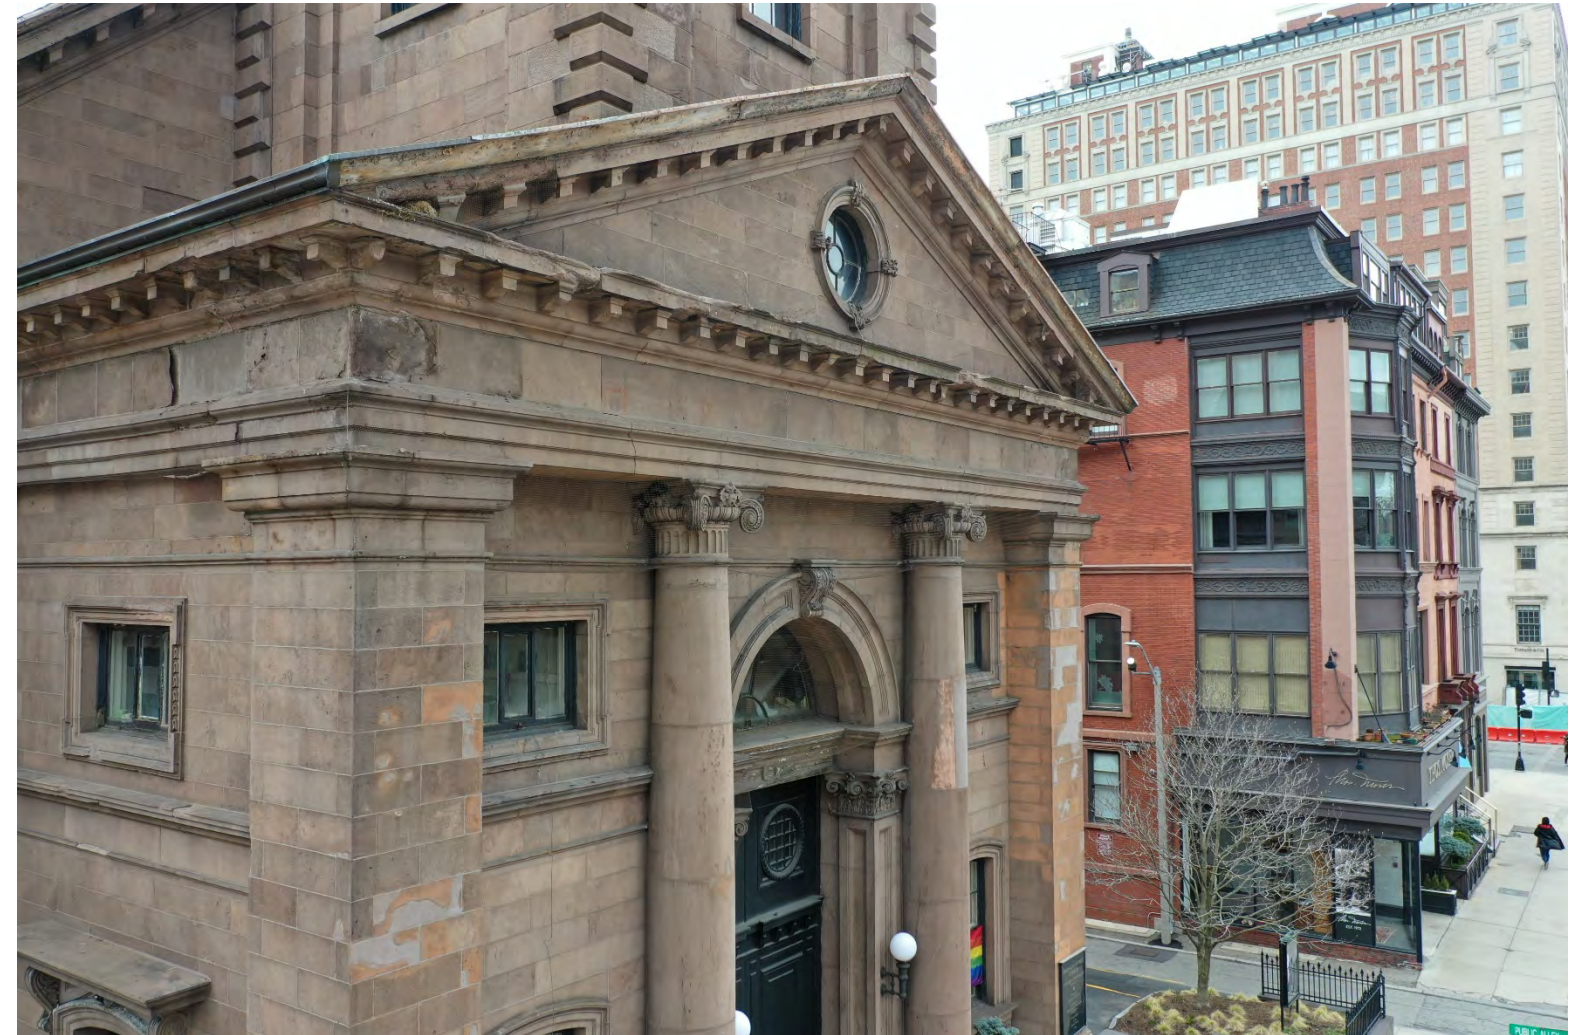
View of portico projecting cornice with multiple spalls and large crack. Deteriorated cornices will be replaced with new stone.

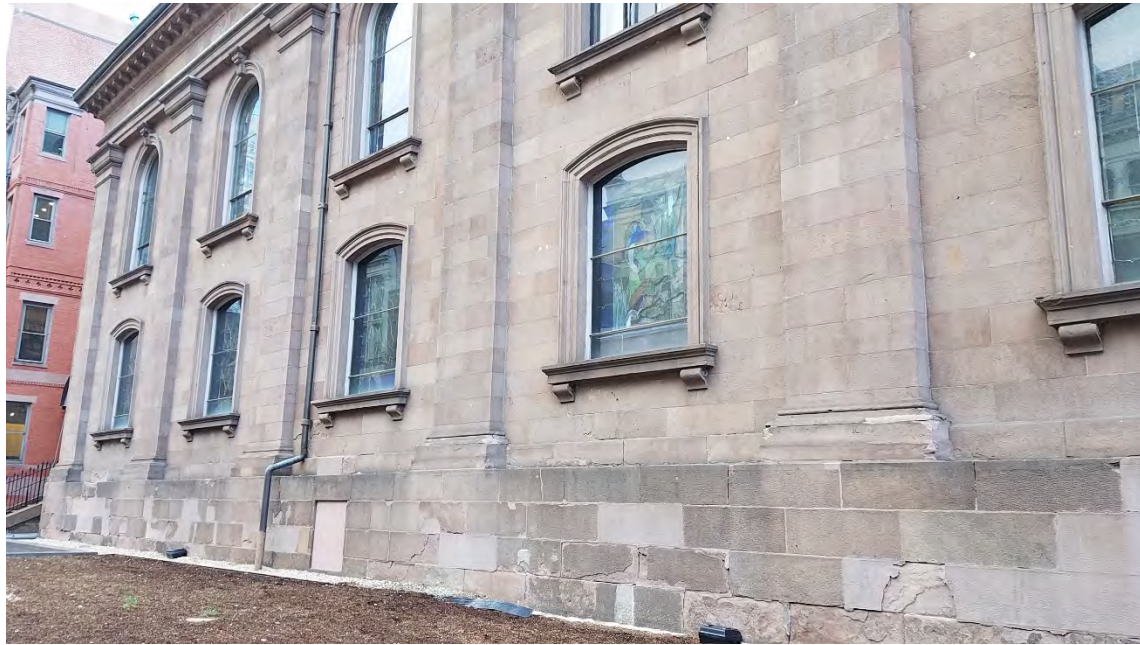
South elevation brownstone water table

The Church's brownstone water table has been a continuously delaminating and spalling over the years. Previous repairs installed a composite mortar patch over the spalled face of stones, but now those patches are failings as well as additional stone units. This area around the base of the entire building will be addressed by installing new stone. In an effort to use the stone that is removed, it will be "harvested" from the building and cut to be used on façade repairs at the front of the Church.

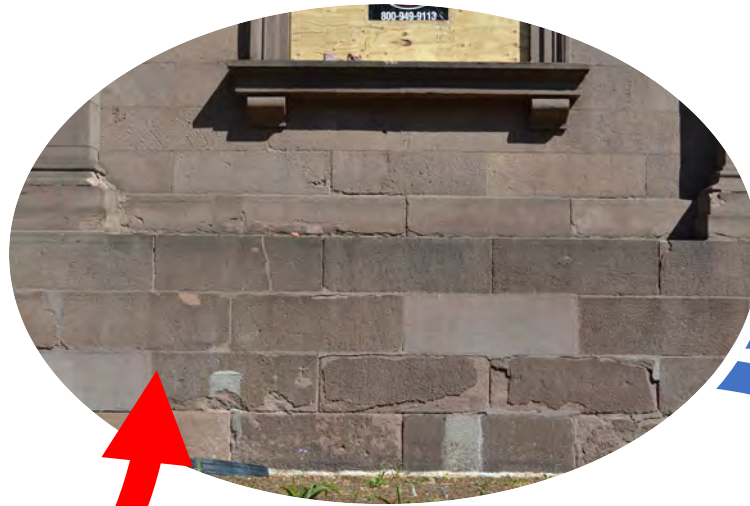
Water table zone indicated in read to be reused or "harvested" from the building. The carefully removed stone will be recut for front facade repairs

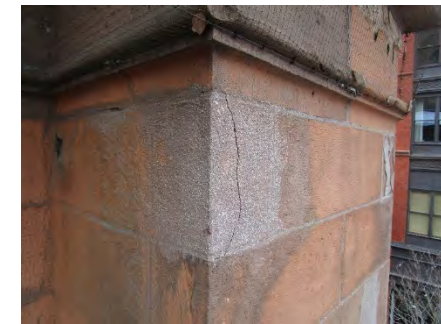
Deteriorated stone at pilaster corners require full stone replacement

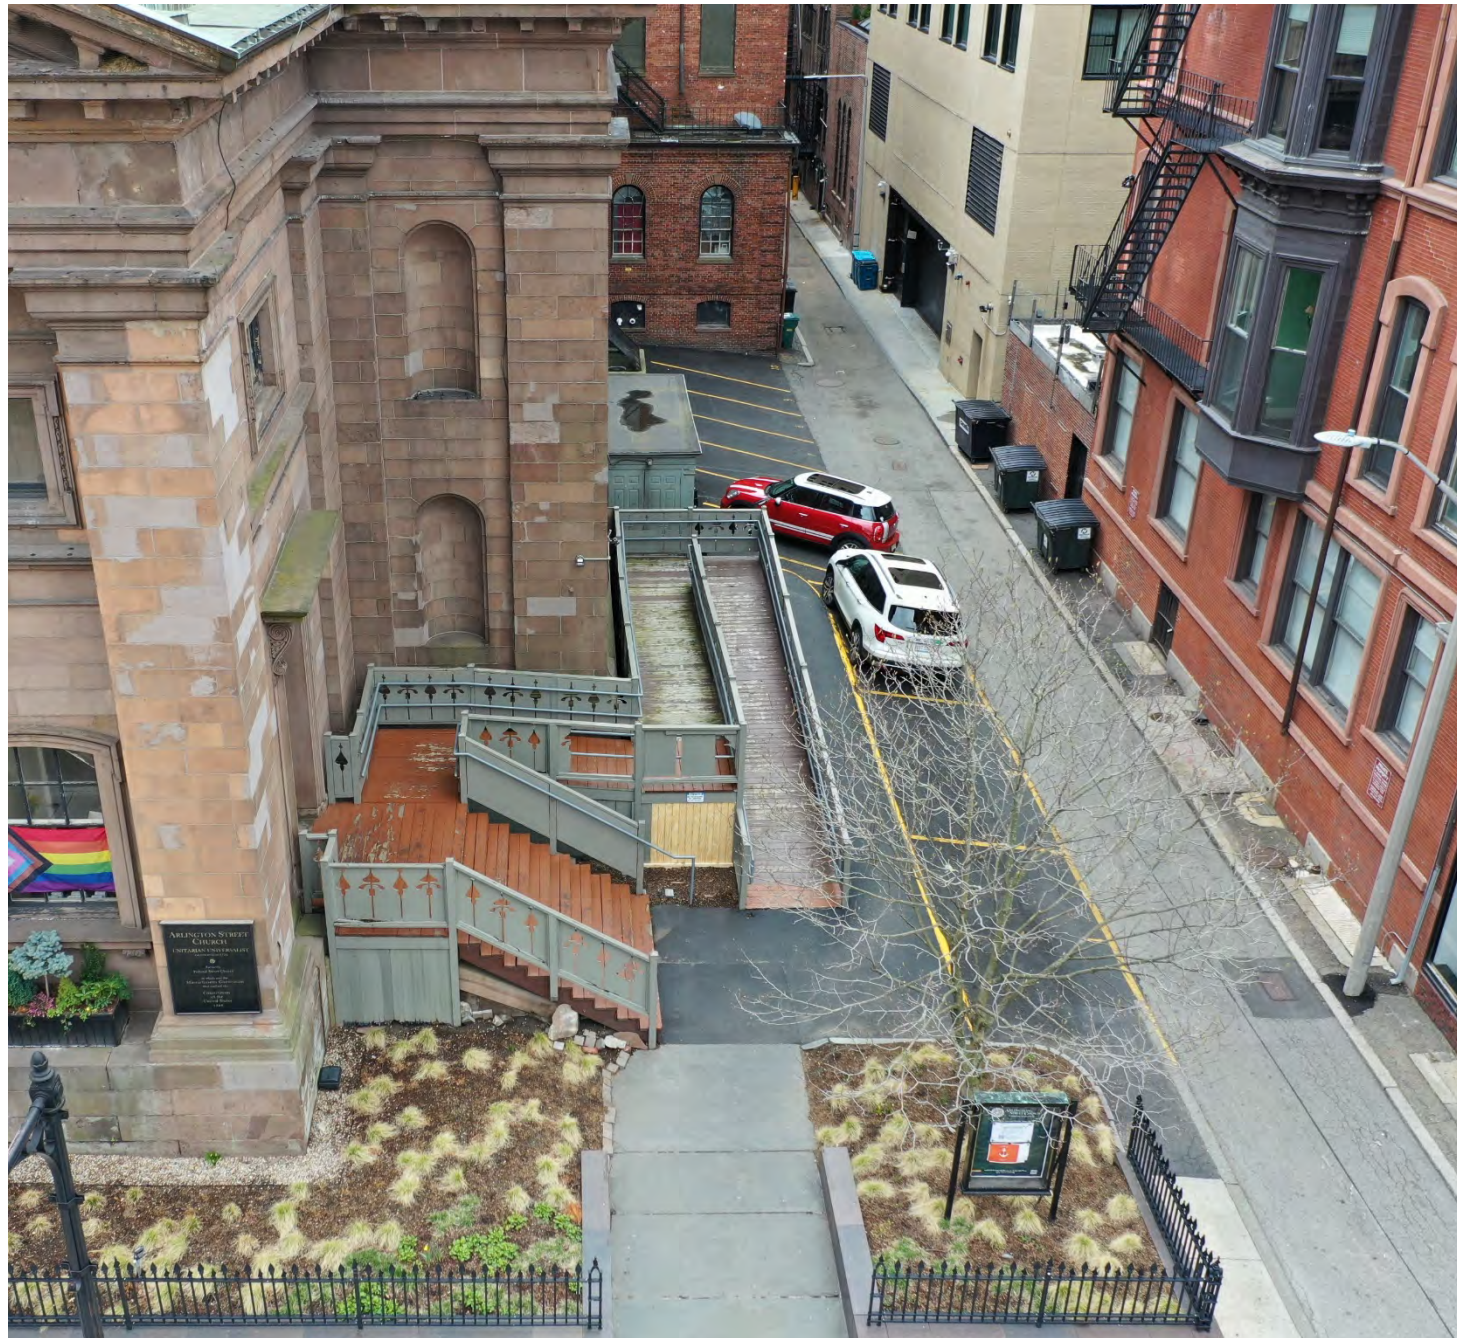
Existing north stair, ramp and basement enclosure

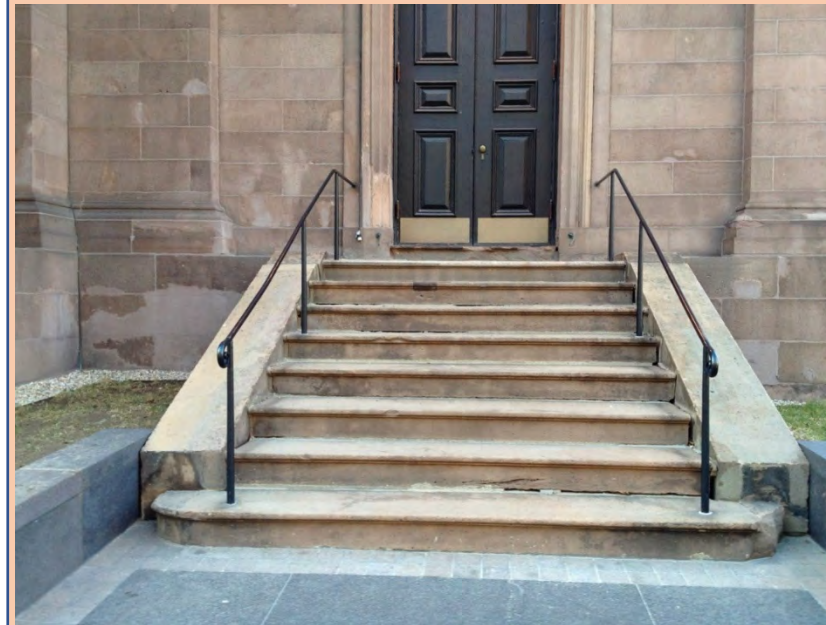
Photograph of existing south stairs before removal. Note step at door and shallow landing

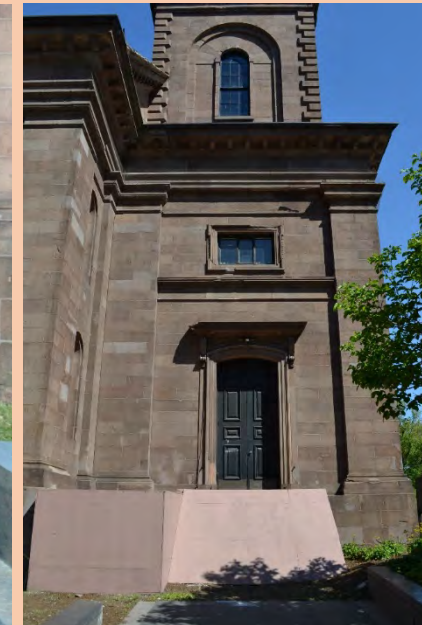
Plywood boxes at south contain the dismantled stairs and stringer

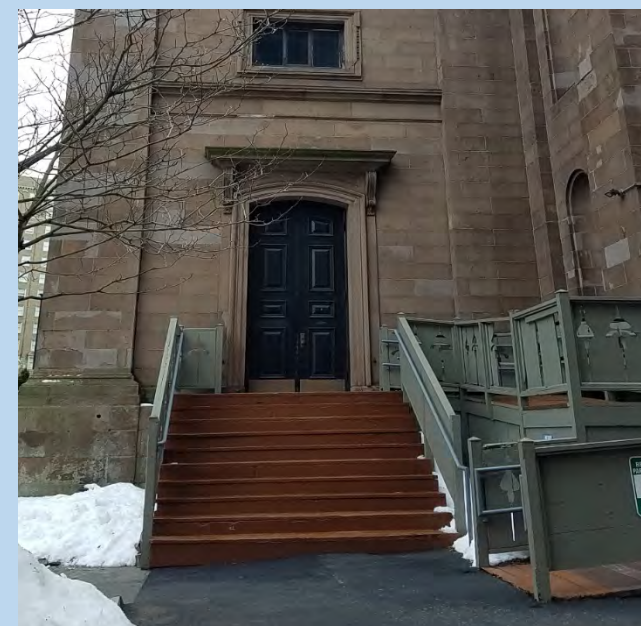
Existing north wood stairs constructed on top of original stone stairs
