Exterior Brownstone Assessment

Arlington Street Church

The Foundation for the Preservation of 20 Arlington Street, Inc.
Boston, MA

28 March 2018

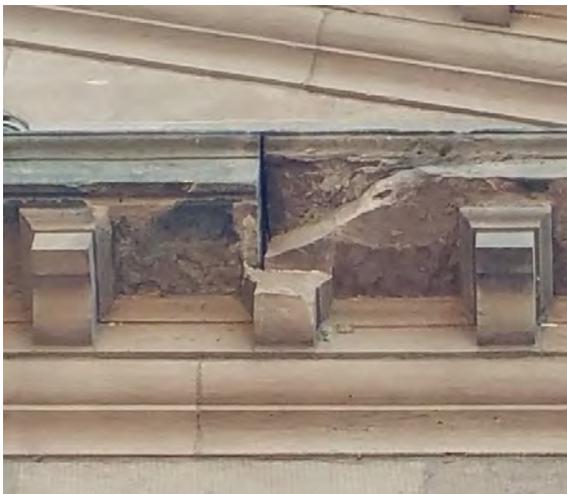
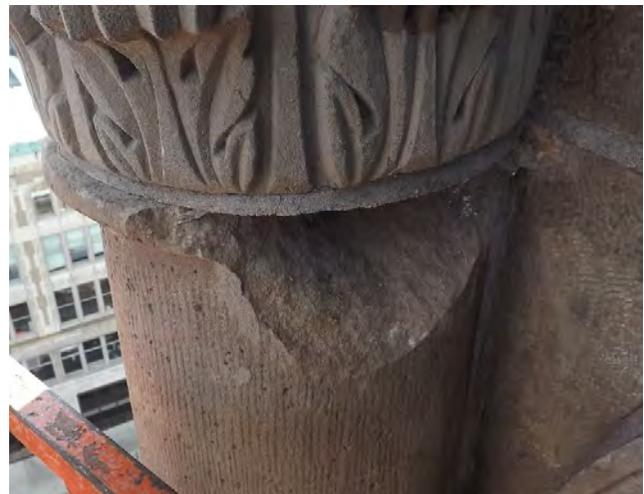
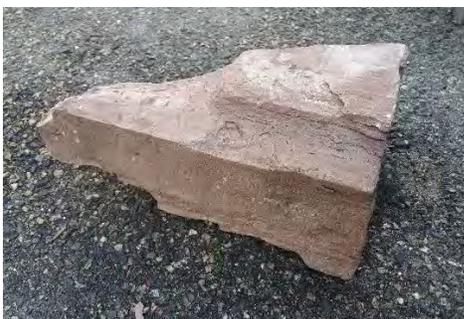
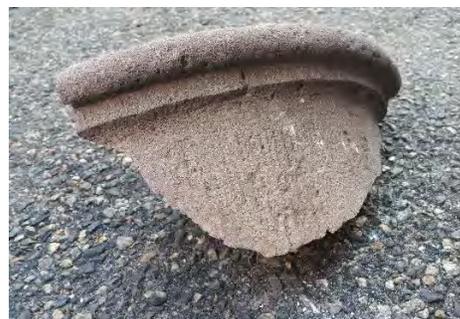
Several hundred pounds of loose deteriorated stone – enough to fill about ten five-gallon buckets – was removed during the survey. Also removed were two large intact chunks of stone – one located 35 feet directly above the main entrance to the church and another from an engaged column at the lantern level of the steeple 125 feet above Arlington Street and the church entrance.

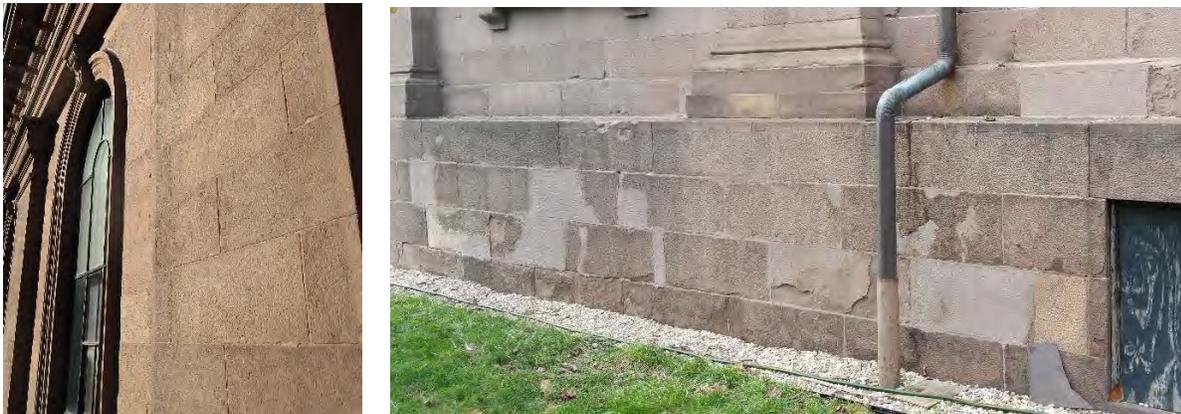
The condition of the exterior masonry varies considerably from location to location. The large expanse of stone along the north and south walls of the nave is in very good condition, including most of the window sills and trim, and does not require a significant amount of work. The base at grade, however, has a variety of issues including open joints, deterioration of original stone, and a large array of unsuccessful patching attempts. It appears that drainage has been installed to address issues of rising damp at the base.

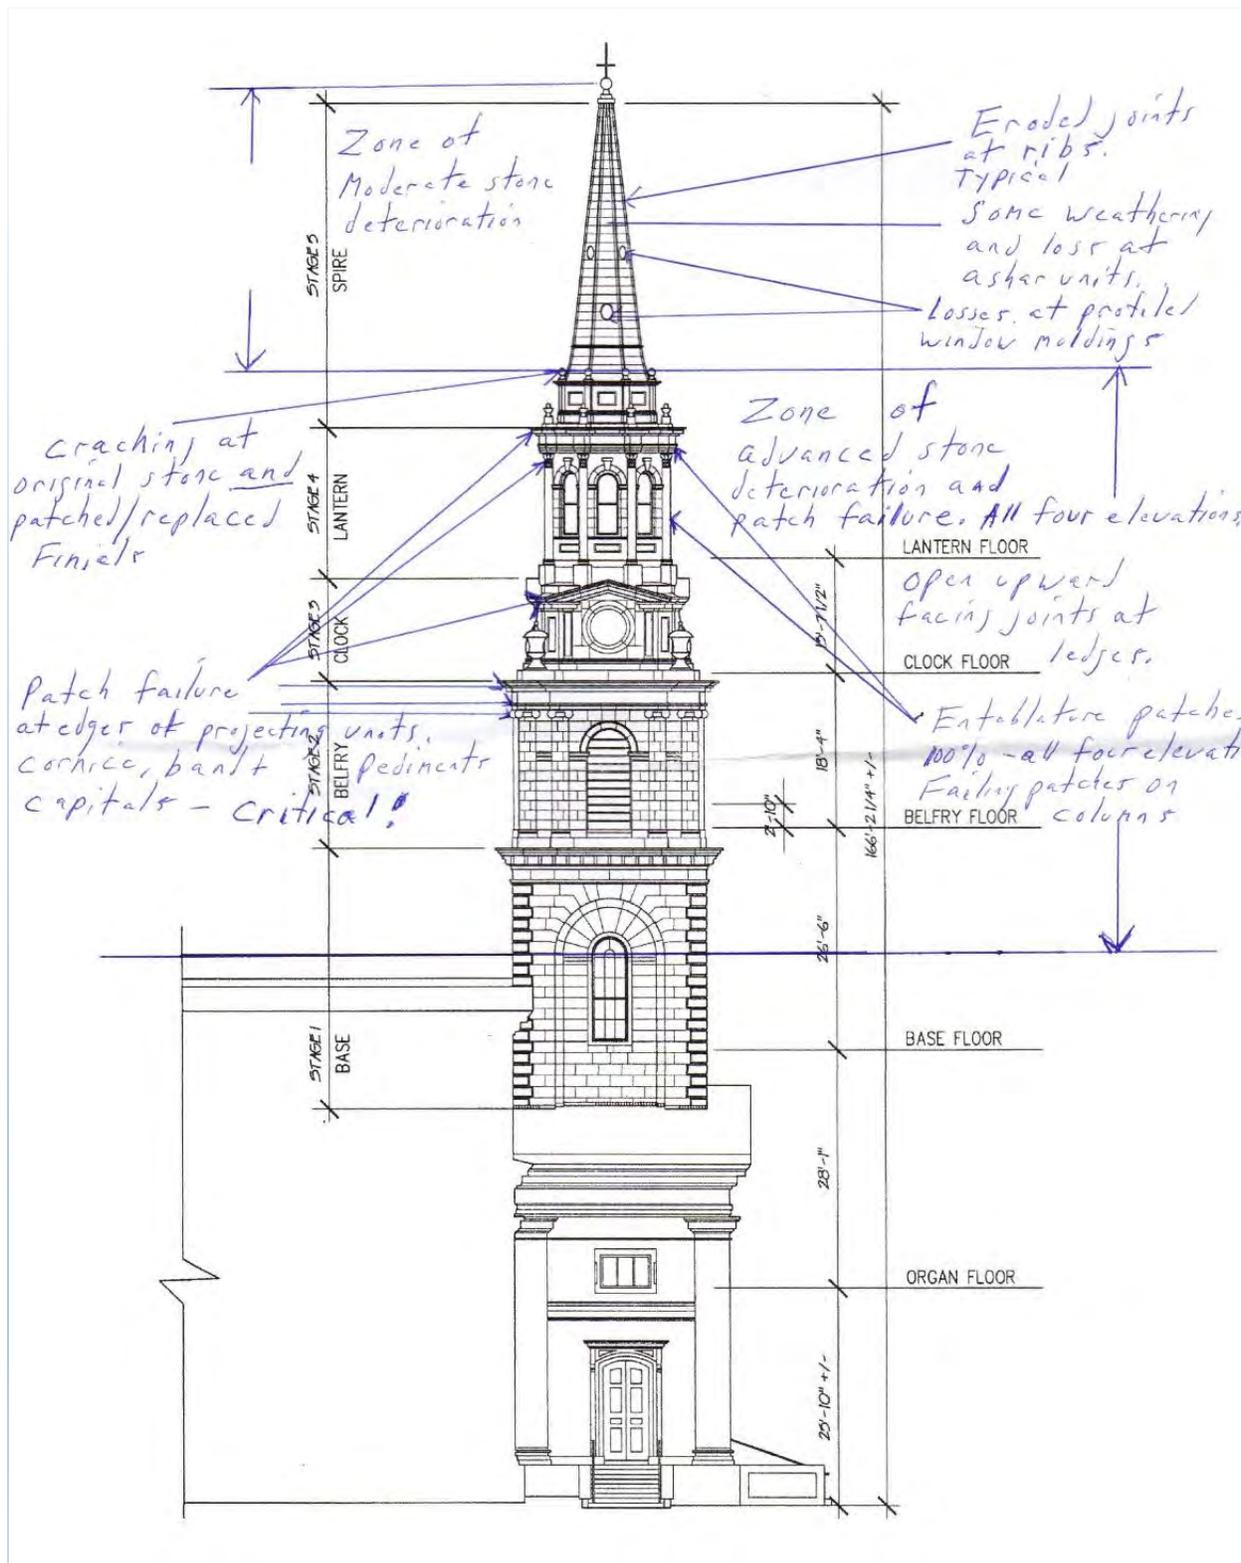
In contrast to the good condition of the nave walls, the stonework on the steeple located in a zone that extends from just below the belfry floor to a line just above the top of the lantern is in very poor condition. Within this zone the issues are not just severe weathering of the sandstone but also the cracking and failure of mortar patches applied at least 20 years ago.

The failure of previous patches applied to the stone represents as large a potential safety hazard as the weathering of the brownstone units. This is because the patches were applied over the weathered edges of units that project from the wall plane as well as, in many cases, the undersides of the same units. The principal mode of failure in the patches is cracking and debonding of the patch material itself. The deterioration of the patches has been accelerated by the ongoing weathering of the stone substrate below the patch. Most of the patch failure appears to be related to the manner in which it was applied – in a relatively thin layer across broad expanses of the stone, and in some instances applied across existing mortar joints. The deterioration of the brownstone itself on the other hand appears to be closely related to the deferred maintenance of failed and open upward facing mortar joints.

While the conditions in this zone of the steeple were partially mitigated by removing loose and friable stone and failing patches during the inspection of December 2017, it was not possible safely reach and remove all the stone and failing mortar patches on the steeple that presently constitute a potential safety hazard. From a safety perspective, addressing the stone and patch deterioration that was observed on the lower section of the steeple is the highest priority for the exterior of the Arlington Street Church.

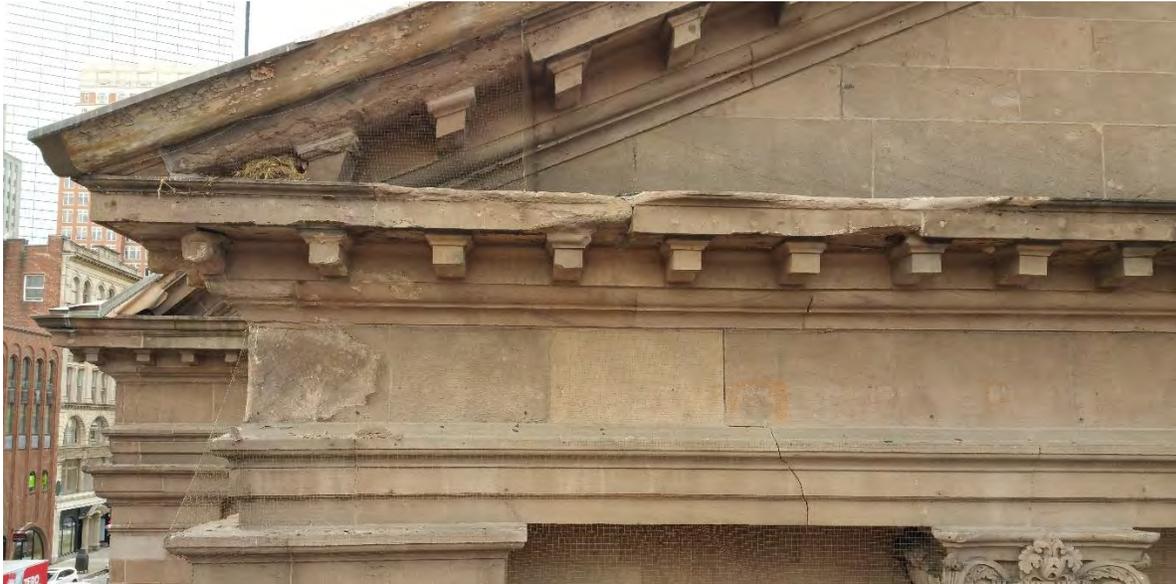
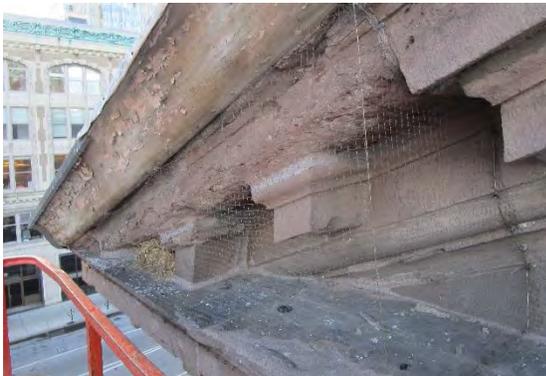
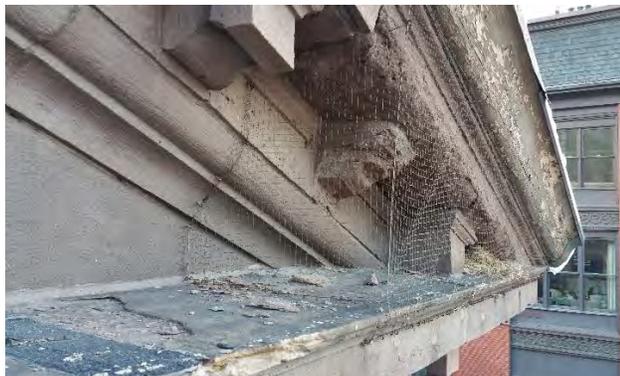
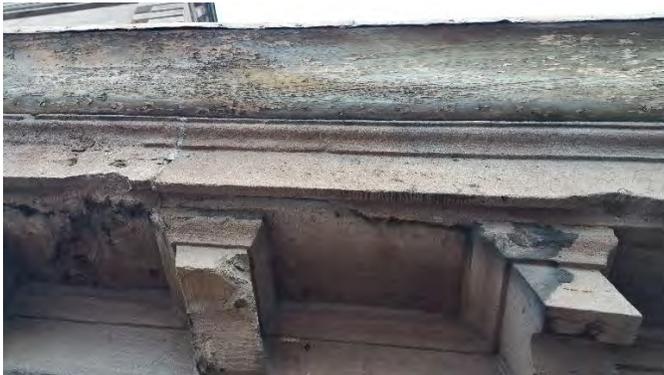
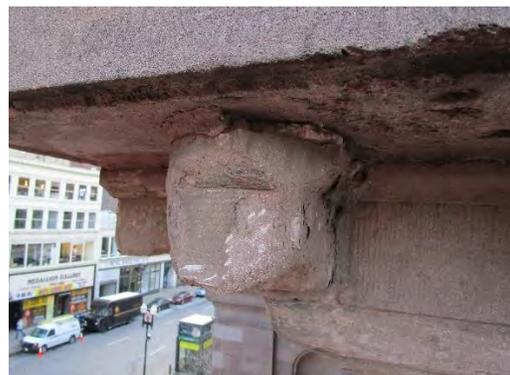
A second zone of advanced deterioration is located along the horizontal and raking cornices of the pediment of the portico on the east entry elevation. At the north and south ends of the pediment, the corner blocks that form the intersection of the horizontal and raking cornices are in very poor condition as are many of the modillion blocks located directly below the cornices. The crown of the raking cornice is wood.

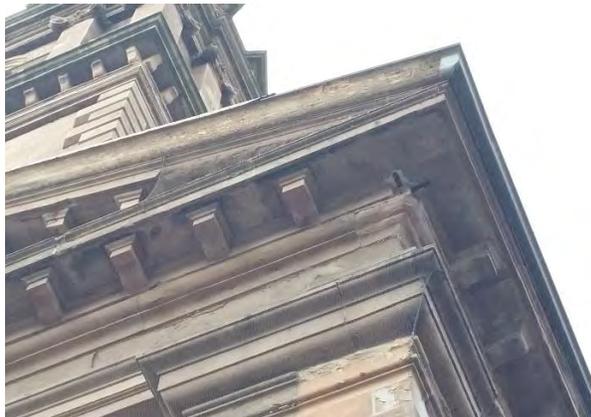
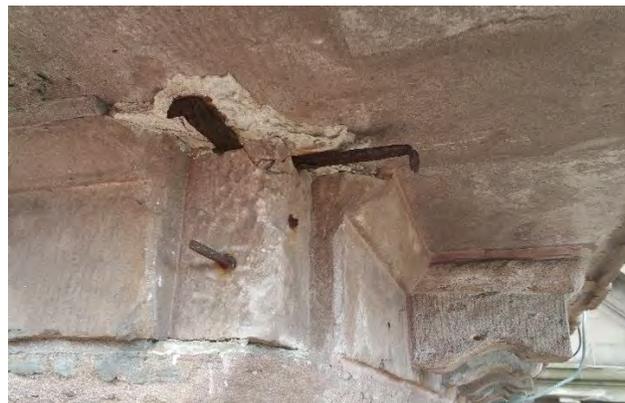
On the underside of the northeast corner of the pediment, the original corner modillion blocks are missing, having been removed or possibly detached on their own at some point in the past. Three iron anchors that originally secured the corner modillion blocks to the building are visible where the blocks detached. It is likely that the stone detachment was caused by the corrosion and subsequent expansion of the original iron anchors used to secure the modillion blocks to the wall. The remaining corner modillion blocks were checked during the survey and no current problems were observed; however, corrosion likely exists and replacing the original anchors before they cause the stone to fail is a high priority for the near future.

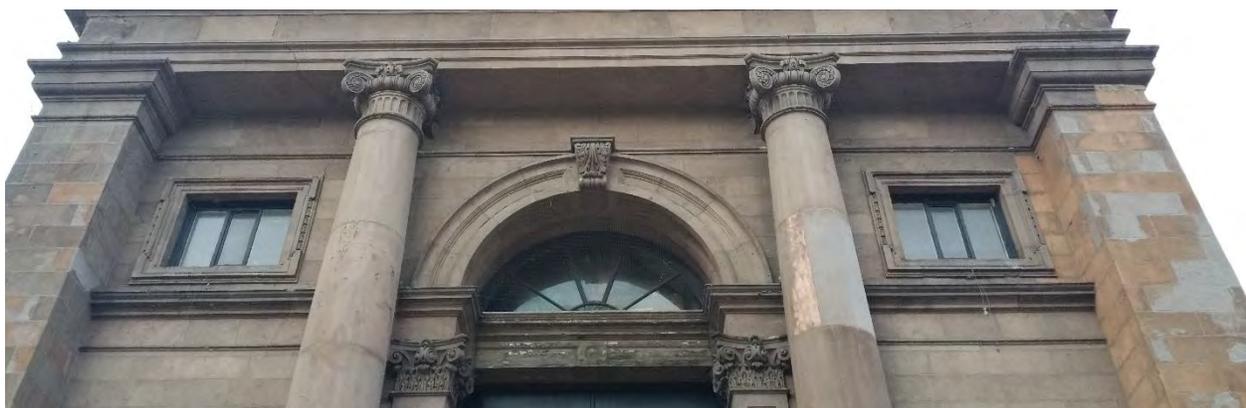
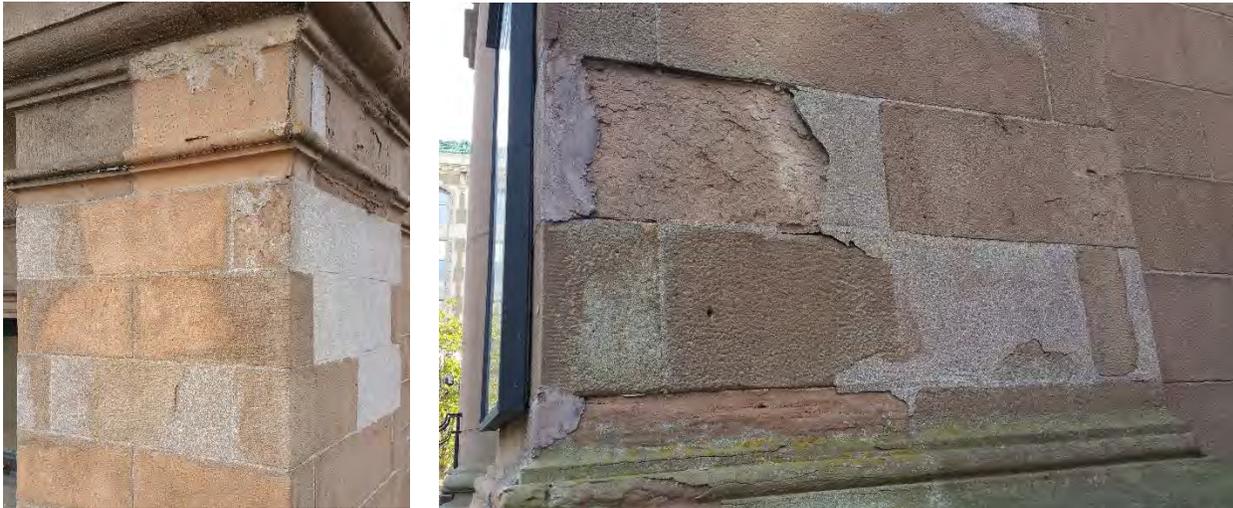
There are a significant number of unsightly large but relatively shallow patches on the columns and the east elevation ashlar that have reached the end of their service life. These patches, which are highly visible due to a color shift over time, date from a generation even earlier than the failing patches located at the mid-section of the steeple.

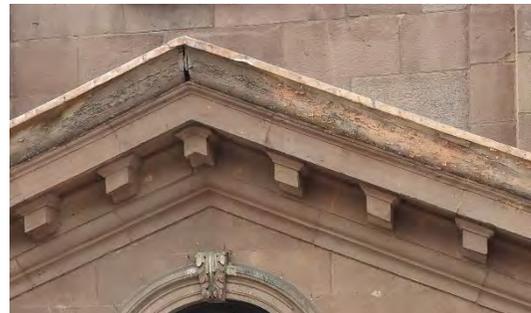
On the east elevation at the pediment of the portico and at the flanking half-pediments of the main body of the church, the raking brownstone cornice has a wood crown detail. The wood is in need of conservation treatment, repair and special paint to preserve what is believed to be original wood building fabric. Restoration of its sanded paint finish should mimic the appearance of the adjacent stone.

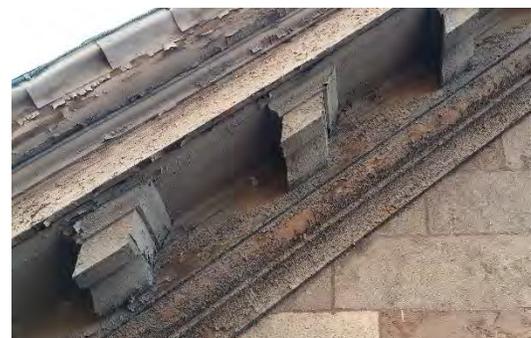
On the west elevation of the church above the Parish House, the raking cornice is detailed entirely of wood – modillions, fascia as well as crown. The wood appears to need less overall conservation attention, but localized repairs to preserve what is believed to be largely original wood building fabric, except locations of previous repair/replacement. Restoration of its sanded paint finish should mimic the appearance of the adjacent stone.

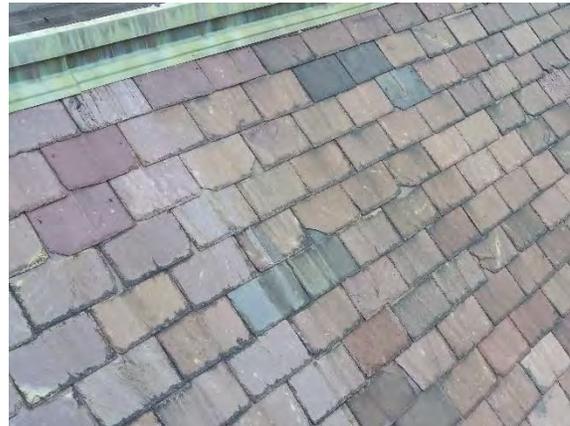
The church roof is primarily of slate, with membrane roofing at certain locations such as the ridge detail, Parish House and some gutters. The portico is a Monson black slate that might be original and is now in need of replacement. It should be replaced only after staging of the steeple is complete. It is understood that the south slope of the main body of the church was re-roofed in 1989. A small amount of repair and slate replacement is warranted there, but at thirty years a quality slate roof should have significant service life remaining. The north slope of the

main body of the church appears to be a mix of slate and is in bad condition and in need of replacement. Using a North Country Black slate is recommended as the contemporary equivalent to the Monson, both aesthetically and for durability and service life. The broad ridge detail at the main body of the church, is currently covered in membrane roofing, which could be repaired for a possible 10-15 years of additional service, however, by taking advantage of when the north side of the church is being staged and the north slope is being re-roofed, investing in its replacement with standing seam copper will provide at least 50 years of service.

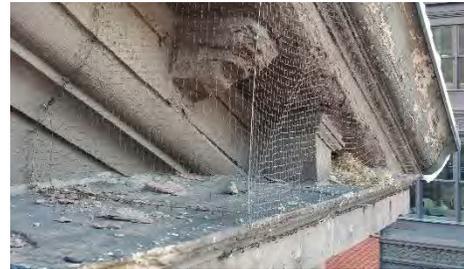
Bird control systems are appropriate for a building with architectural forms and details that provide potential perches and nesting areas. Given its height, the steeple is not considered. There are old systems currently in place, and the scope of work includes their phased replacement with similar but more up to date systems as masonry work is completed.

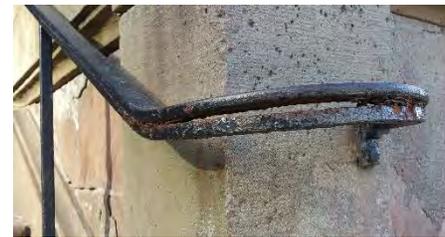
Wrought iron handrails at the main entry steps of the portico are in need of restoration and repair. The scope of work includes them being removed to a specialty shop for restoration, and it anticipates some degree of historically appropriate adjustment and or extension for better performance and compliance.

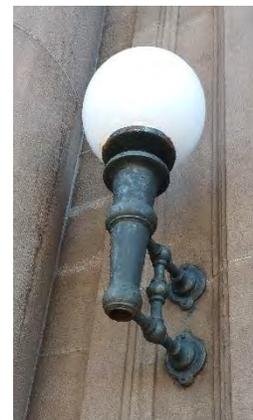
The key exterior lighting elements directly related to the brownstone work are steeple lighting – if it were to be affixed to the steeple – and the two wall sconces at the main entrance of the east portico. There were light sources affixed to the steeple in the past, but they have since been removed, and lighting of the church has been from neighboring public poles and the surrounding landscape. Confirming the current approach, steeple lighting is not likely to be successful with fixtures affixed to the steeple itself, and maintenance of such fixtures would be very difficult. So, the scope of work does not include any provisions for wiring or attaching lighting fixtures to the steeple during the course of the stone work. It does include an allowance for the rewiring and conservation of metal finish of the two wall sconces at the main entrance.
