Restoration and Repair Overview

Master Plan Phases

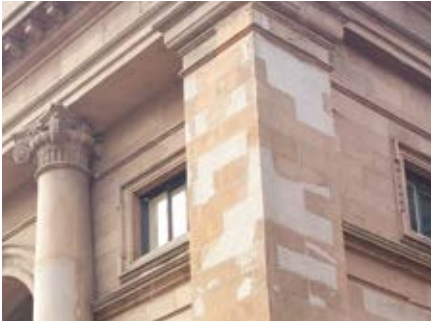
Unsightly and failing patches marring the uniform appearance of the natural stone

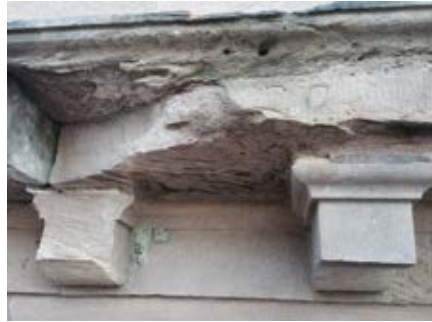
Loss of essential architectural lines and hazardous deterioration over entry

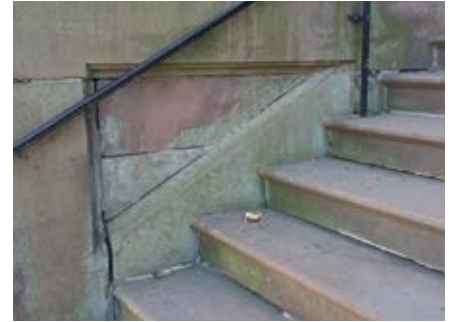
Failing cheek walls on entry stairs with joints open to moisture incursion

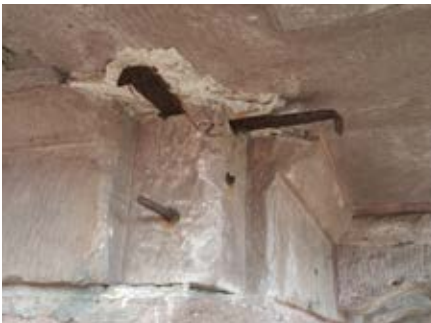
Lost corner modillions leaving ferrous anchors bare and vulnerable to corrosion

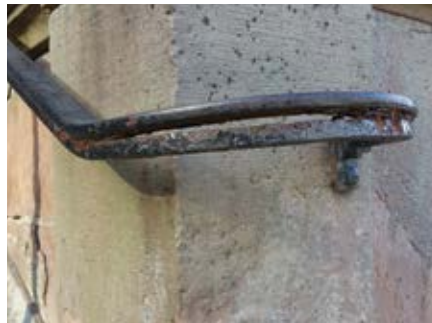
Deteriorating wrought iron handrails at entrance stairway

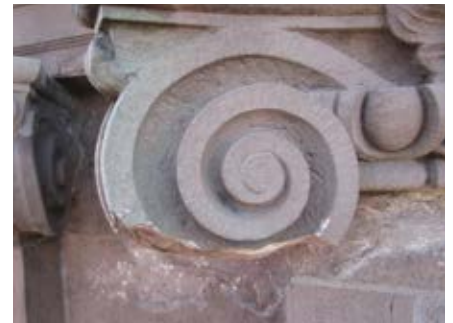
Loss of essential architectural detail in prominent locations

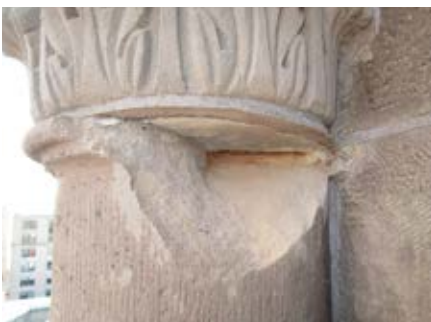
Void after removing a ten-pound piece of unsecured stone perched directly over the entrance

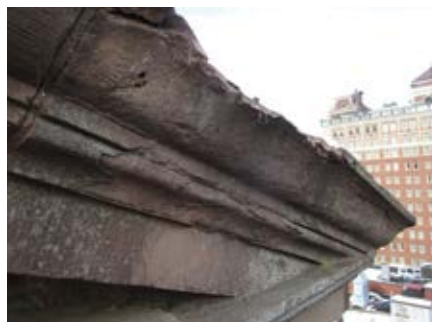
Leading edges of detail with extreme deterioration, friable stone, moisture damage, and biological growth

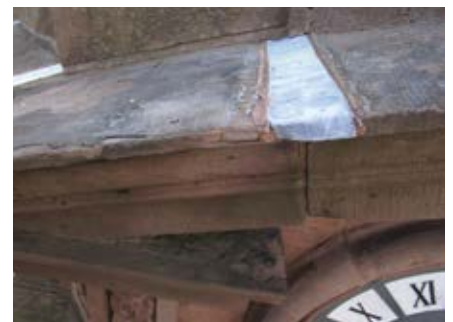
Skyward facing joints that have suffered failed treatments and remain open to moisture incursion
