Exterior Brownstone Assessment

Arlington Street Church

The Foundation for the Preservation of 20 Arlington Street, Inc.
Boston, MA

28 March 2018

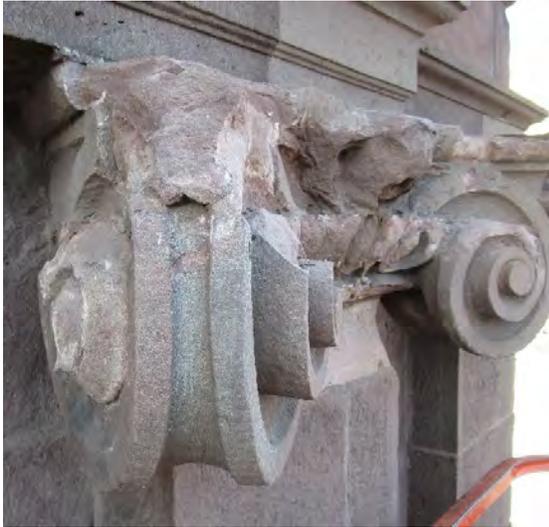
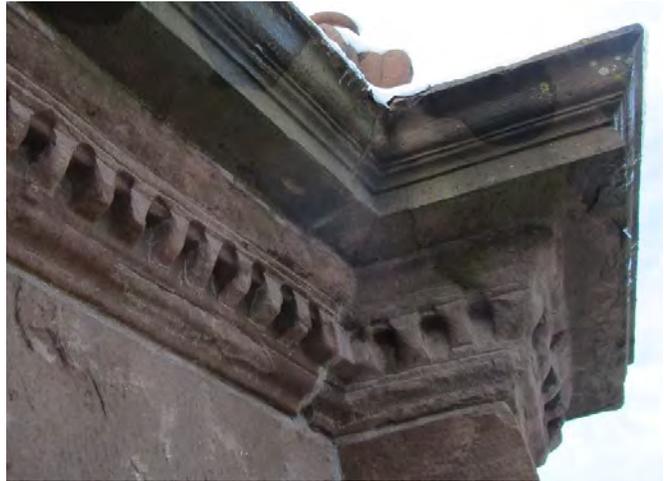
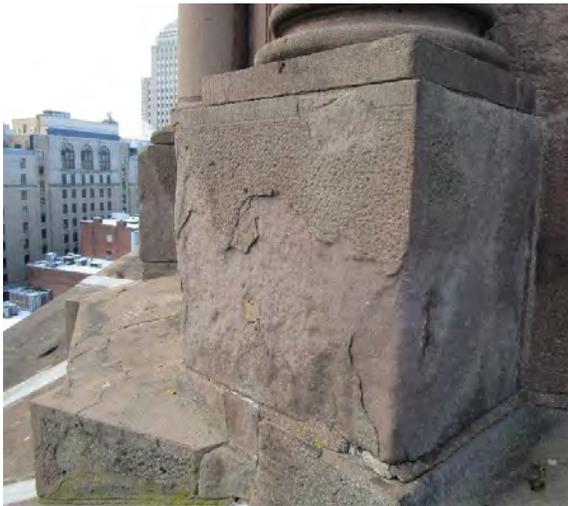
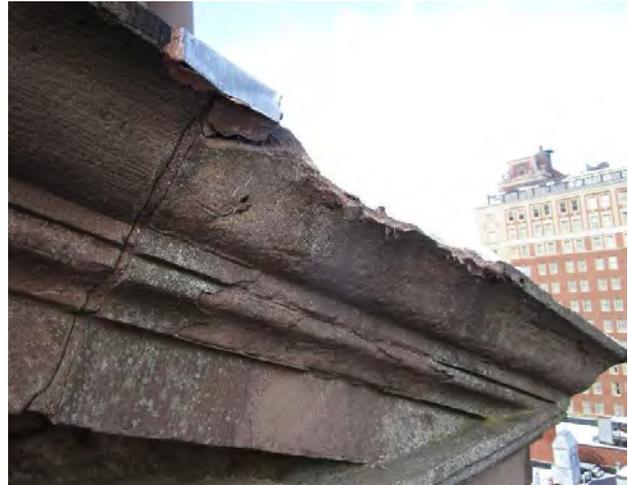
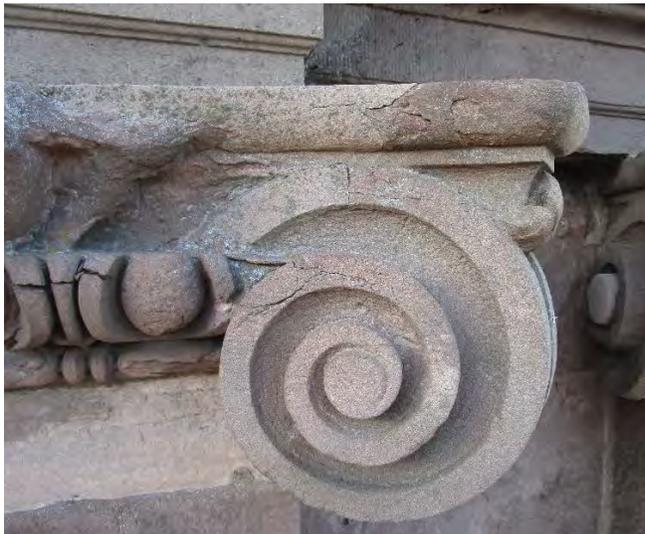
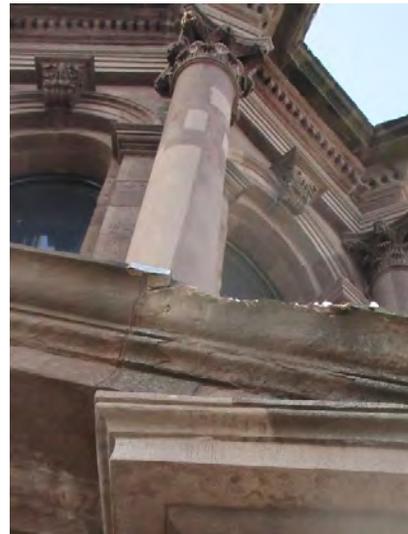
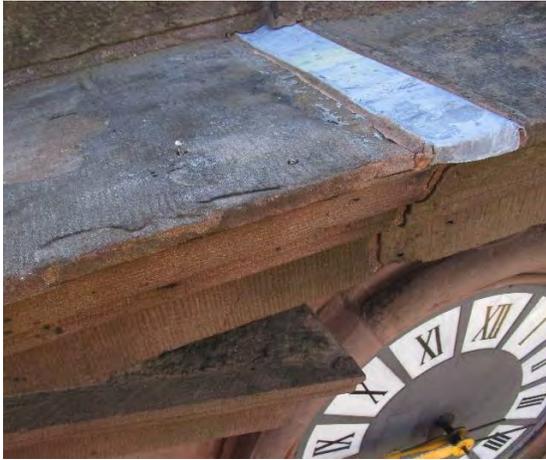
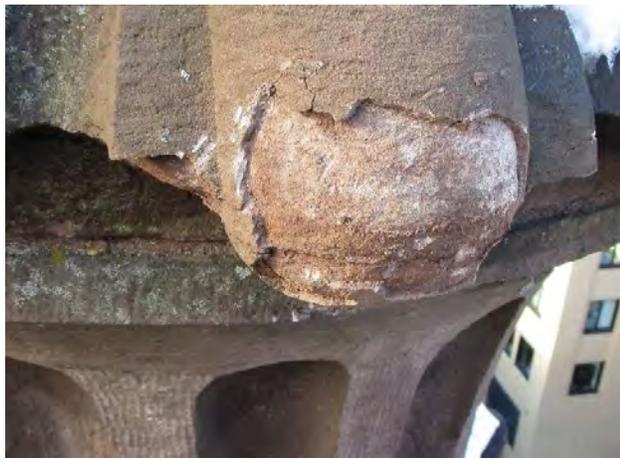
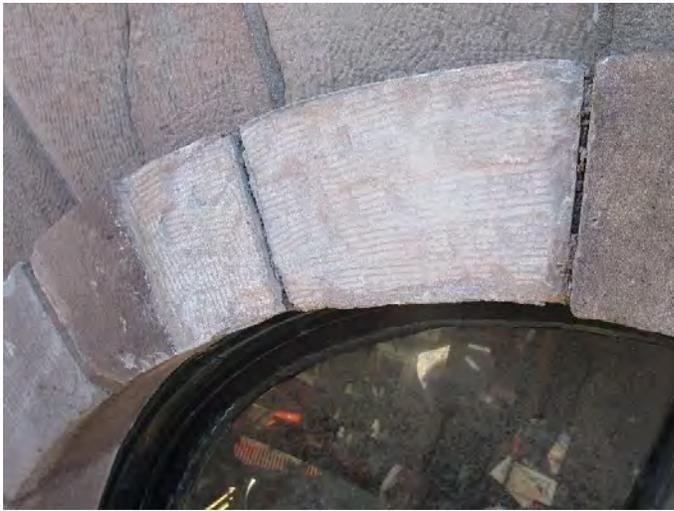
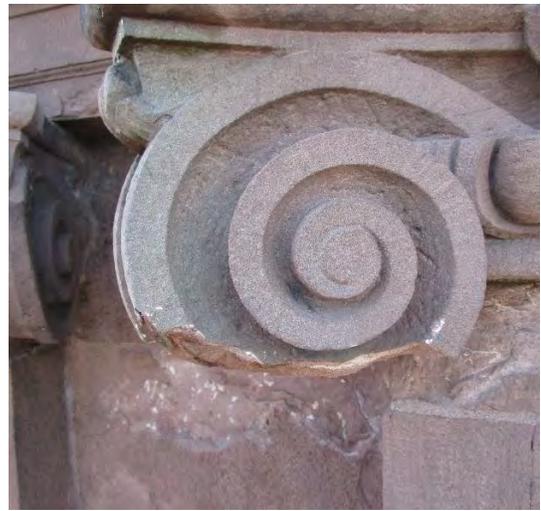
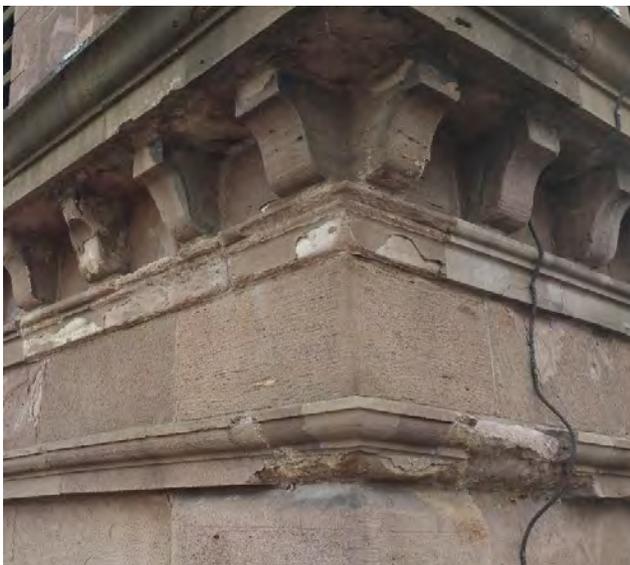
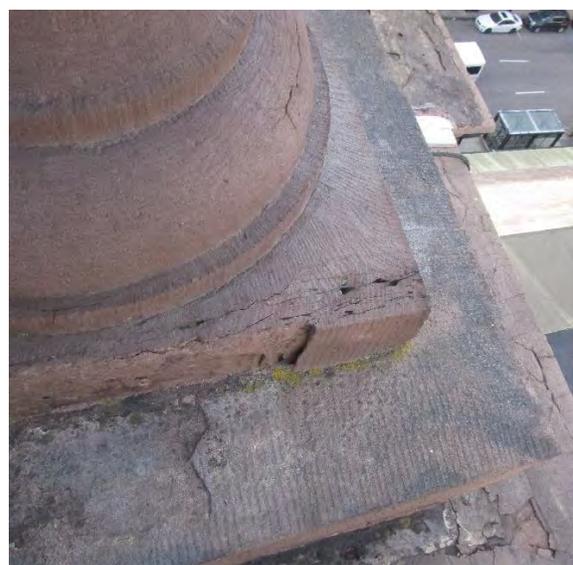
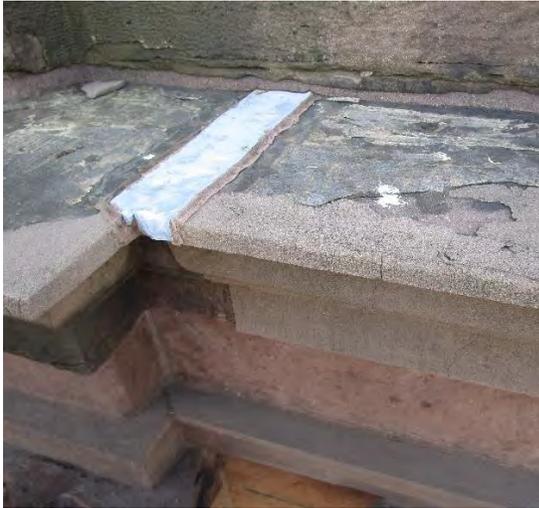
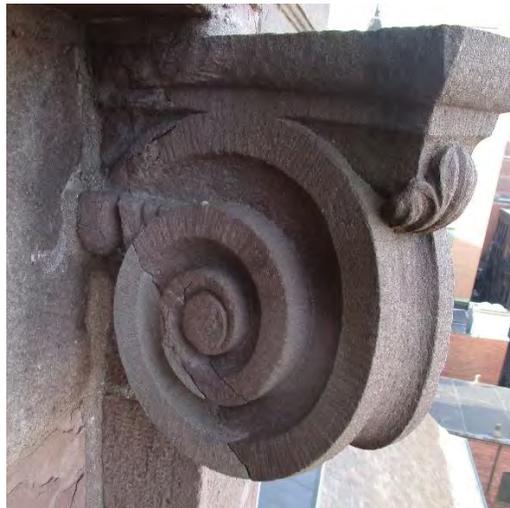
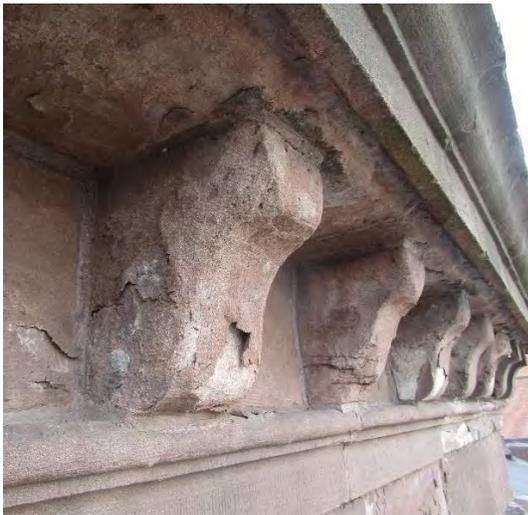
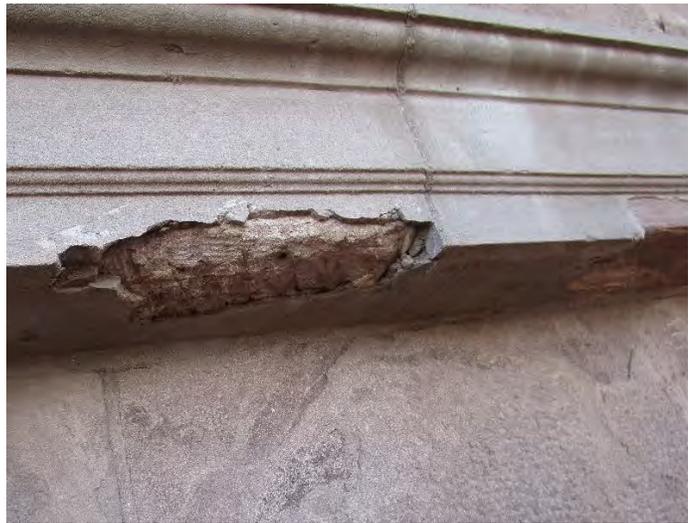
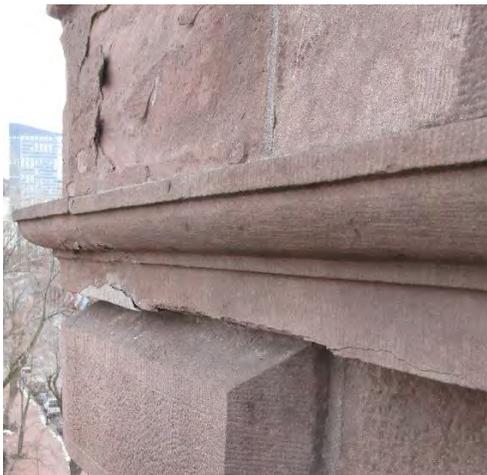
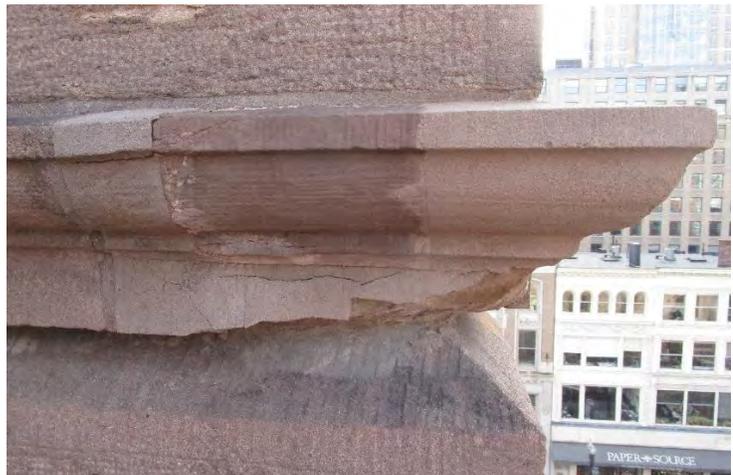
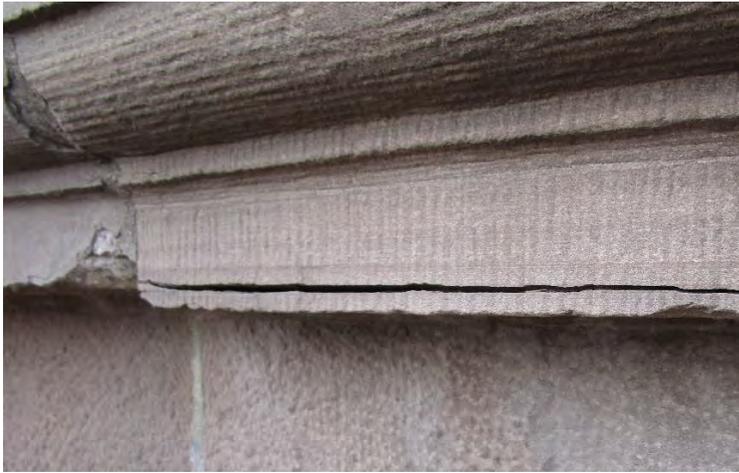
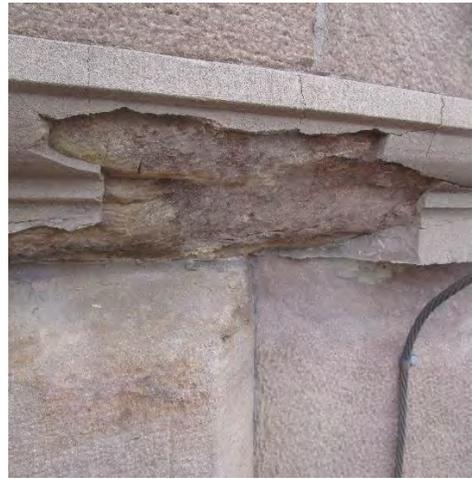
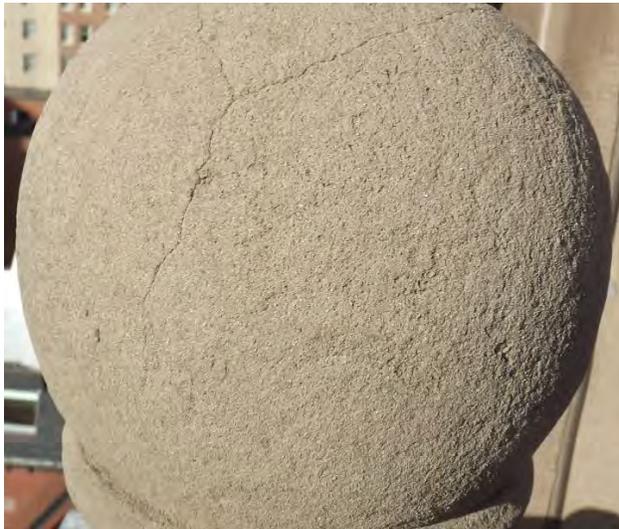
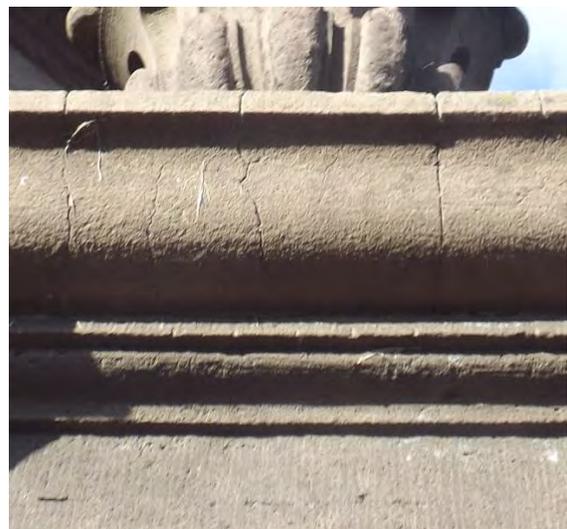
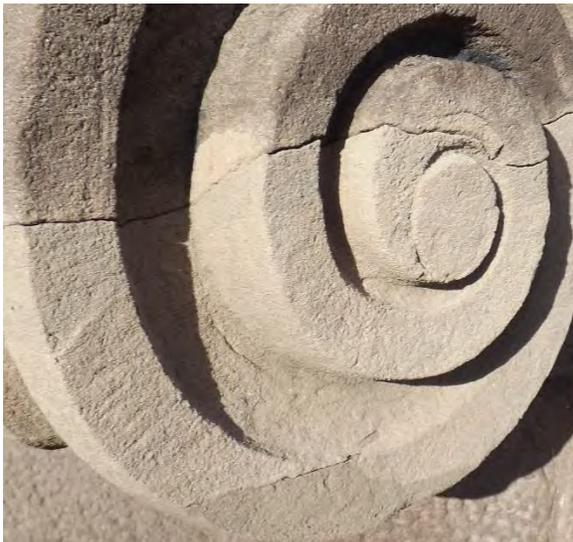
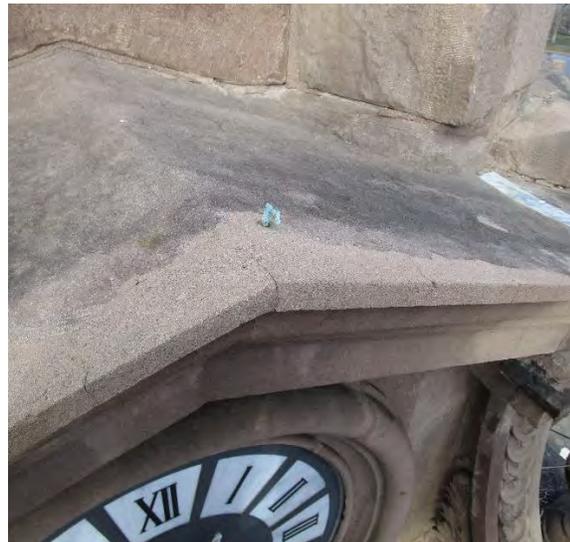
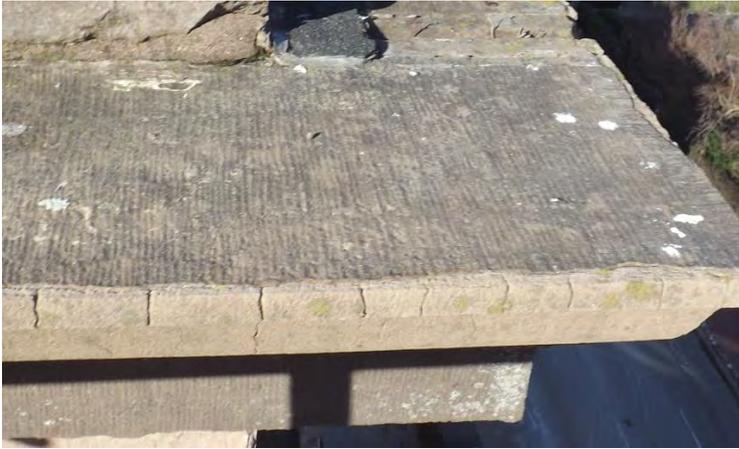
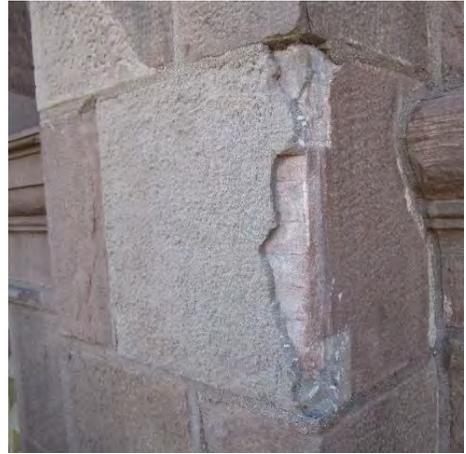
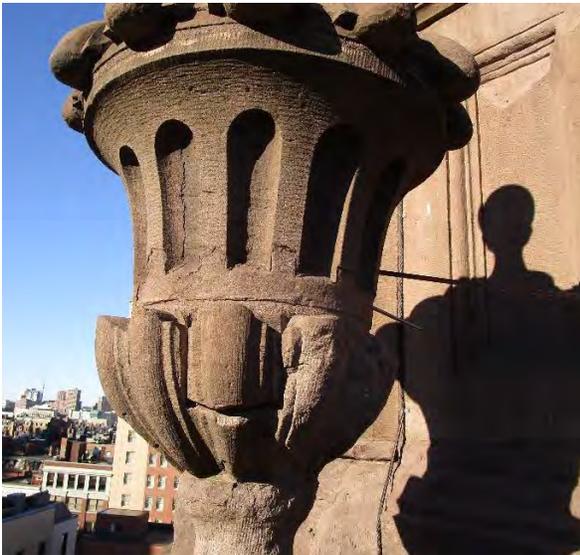
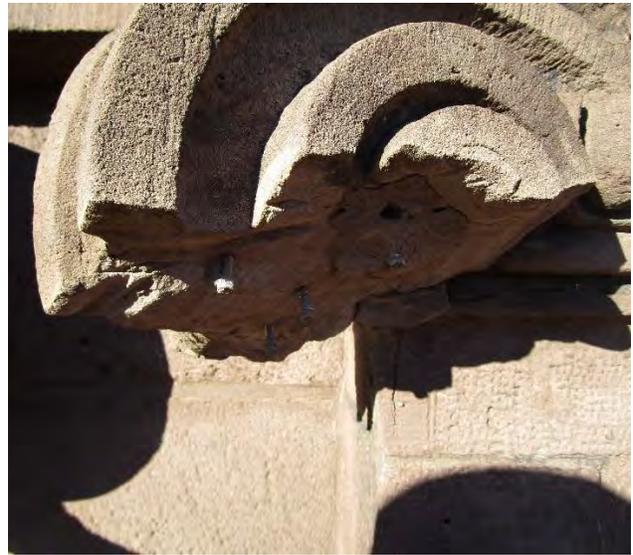
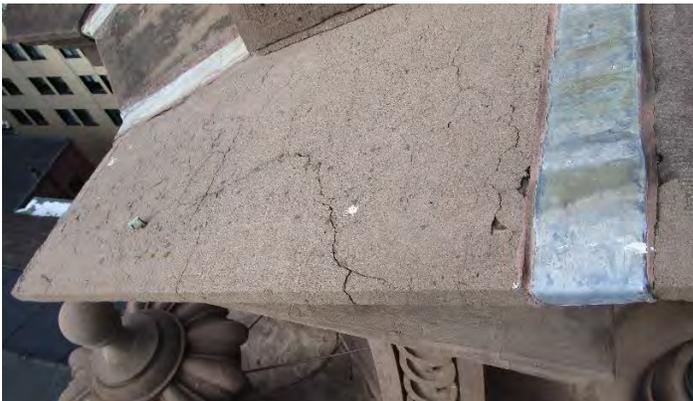
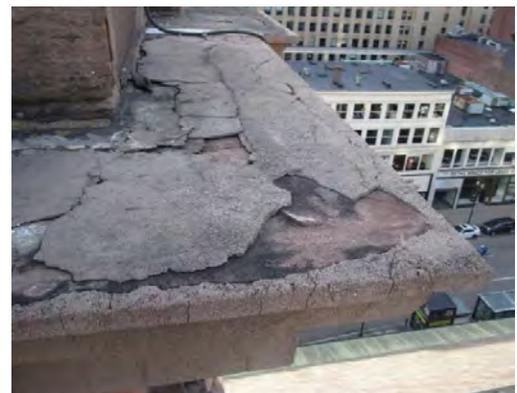
In contrast to the good condition of the nave walls, the stonework on the steeple located in a zone that extends from just below the belfry floor to a line just above the top of the lantern is in very poor condition. Within this zone the issues are not just severe weathering of the sandstone but also the cracking and failure of mortar patches applied at least 20 years ago.

The failure of previous patches applied to the stone represents as large a potential safety hazard as the weathering of the brownstone units. This is because the patches were applied over the weathered edges of units that project from the wall plane as well as, in many cases, the undersides of the same units. The principal mode of failure in the patches is cracking and debonding of the patch material itself. The deterioration of the patches has been accelerated by the ongoing weathering of the stone substrate below the patch. Most of the patch failure appears to be related to the manner in which it was applied – in a relatively thin layer across broad expanses of the stone, and in some instances applied across existing mortar joints. The deterioration of the brownstone itself on the other hand appears to be closely related to the deferred maintenance of failed and open upward facing mortar joints.

While the conditions in this zone of the steeple were partially mitigated by removing loose and friable stone and failing patches during the inspection of December 2017, it was not possible safely reach and remove all the stone and failing mortar patches on the steeple that presently constitute a potential safety hazard. From a safety perspective, addressing the stone and patch deterioration that was observed on the lower section of the steeple is the highest priority for the exterior of the Arlington Street Church.
